Maryland Historical Trust

Name: MILBROOK RD. OVER LITTLE ANTIETAM CREEK

Maryland Inventory of Historic Properties
Historic Bridge Inventory
Maryland State Highway Administration
Maryland Historical Trust

SHA Bridge No. W-5981 Name: Millbrook Road over Little Antietam Creek

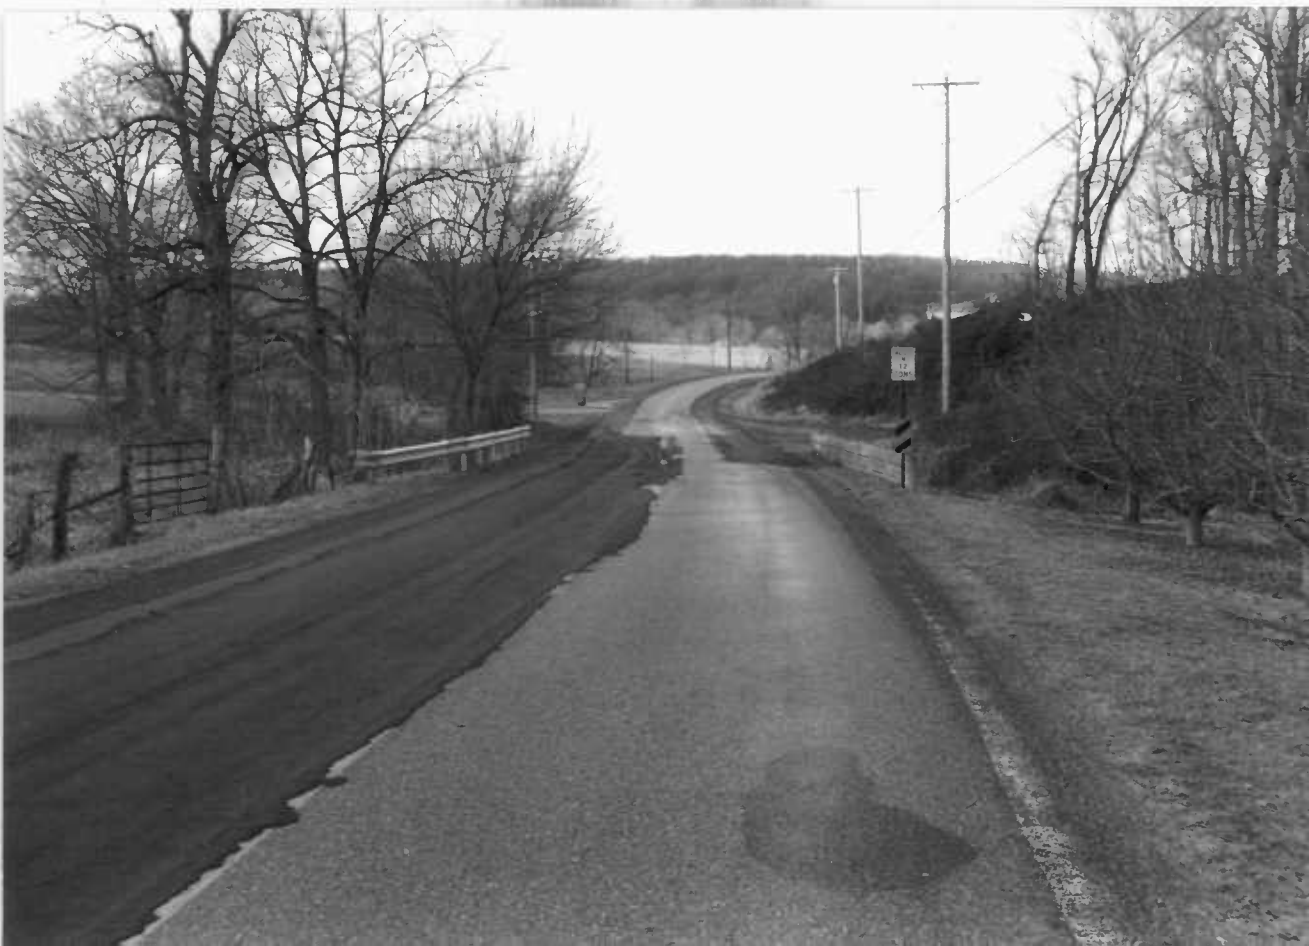
1 OF 4

SOUTHWEST APPROACH

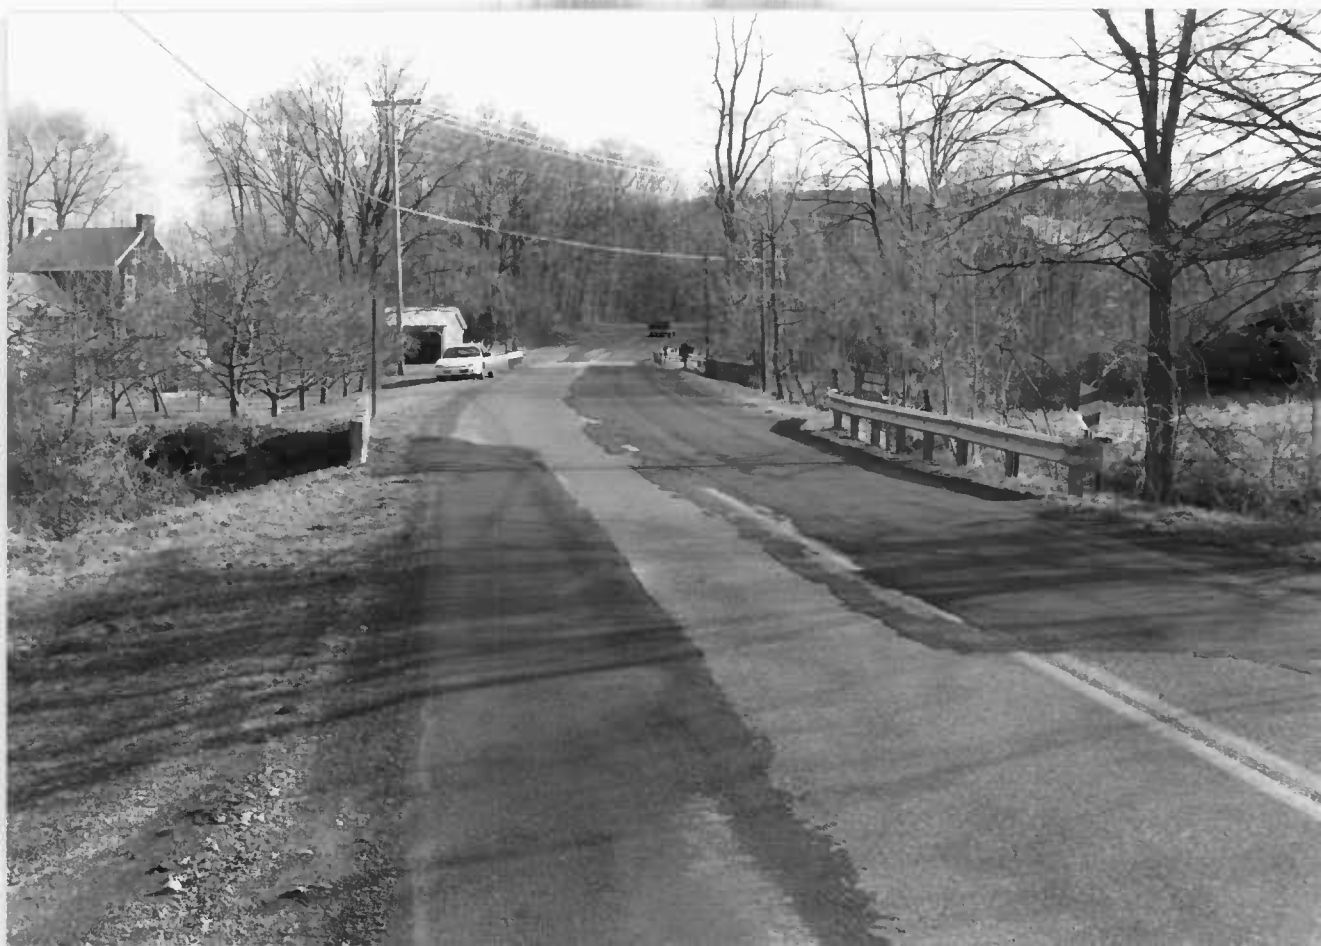
2 OF 4

NORTHEAST APPROACH

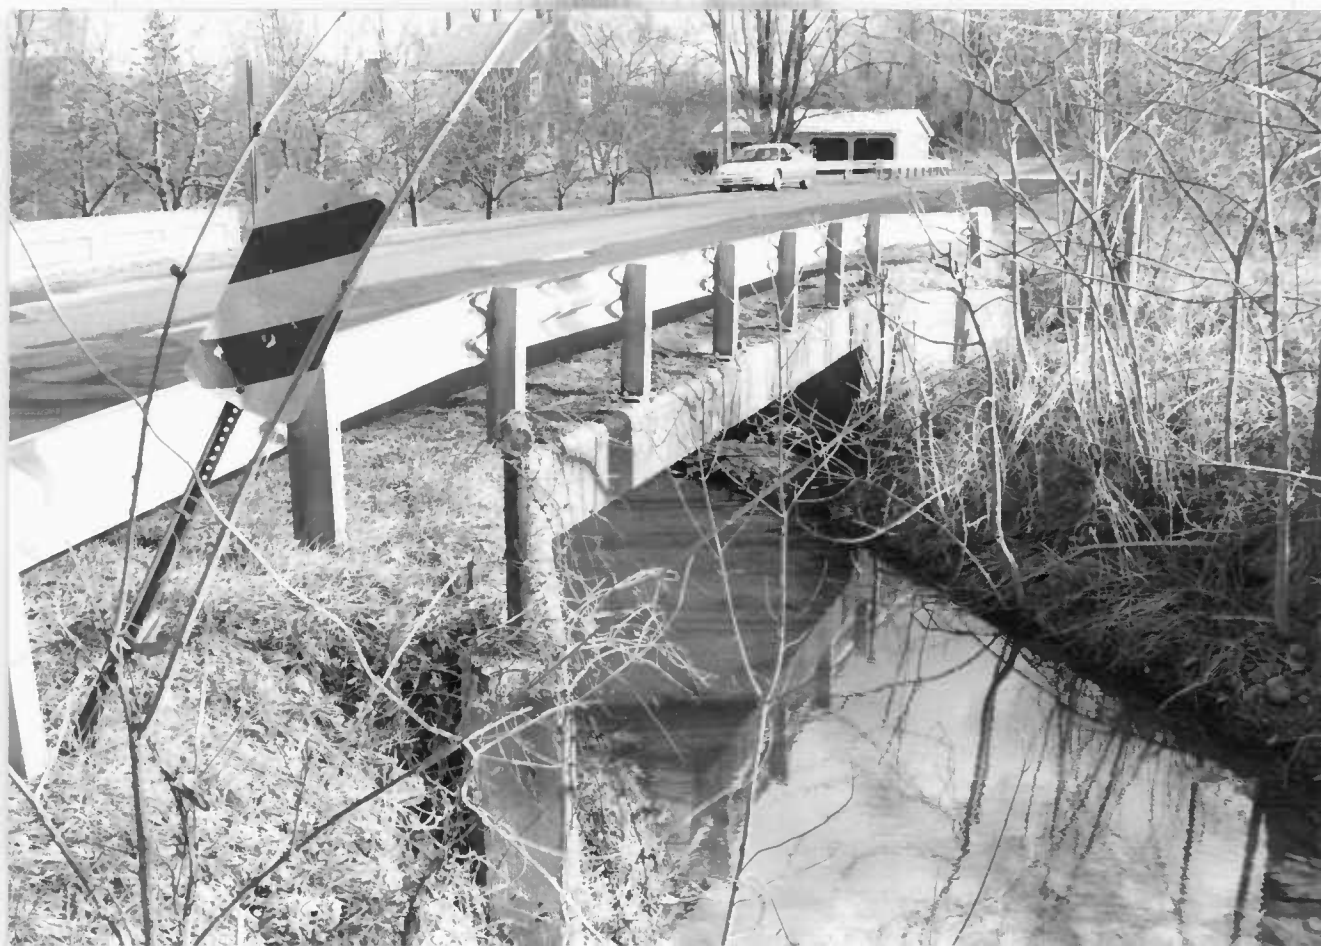
3 OF 4

The northwest side of the bridge is a concrete slab. The slab is approximately 28 feet long and 1 foot thick. The slab has a guardrail and post railing system. The 2-foot 6-inch posts are mounted to the deck of the slab with a steel plate. The slab has concrete wingwalls that are approximately 4 feet 6 inches wide and 3 feet high. The slab, railing, and wingwalls are in good condition with no visible cracks or spalling.

NORTHWEST ELEVATION

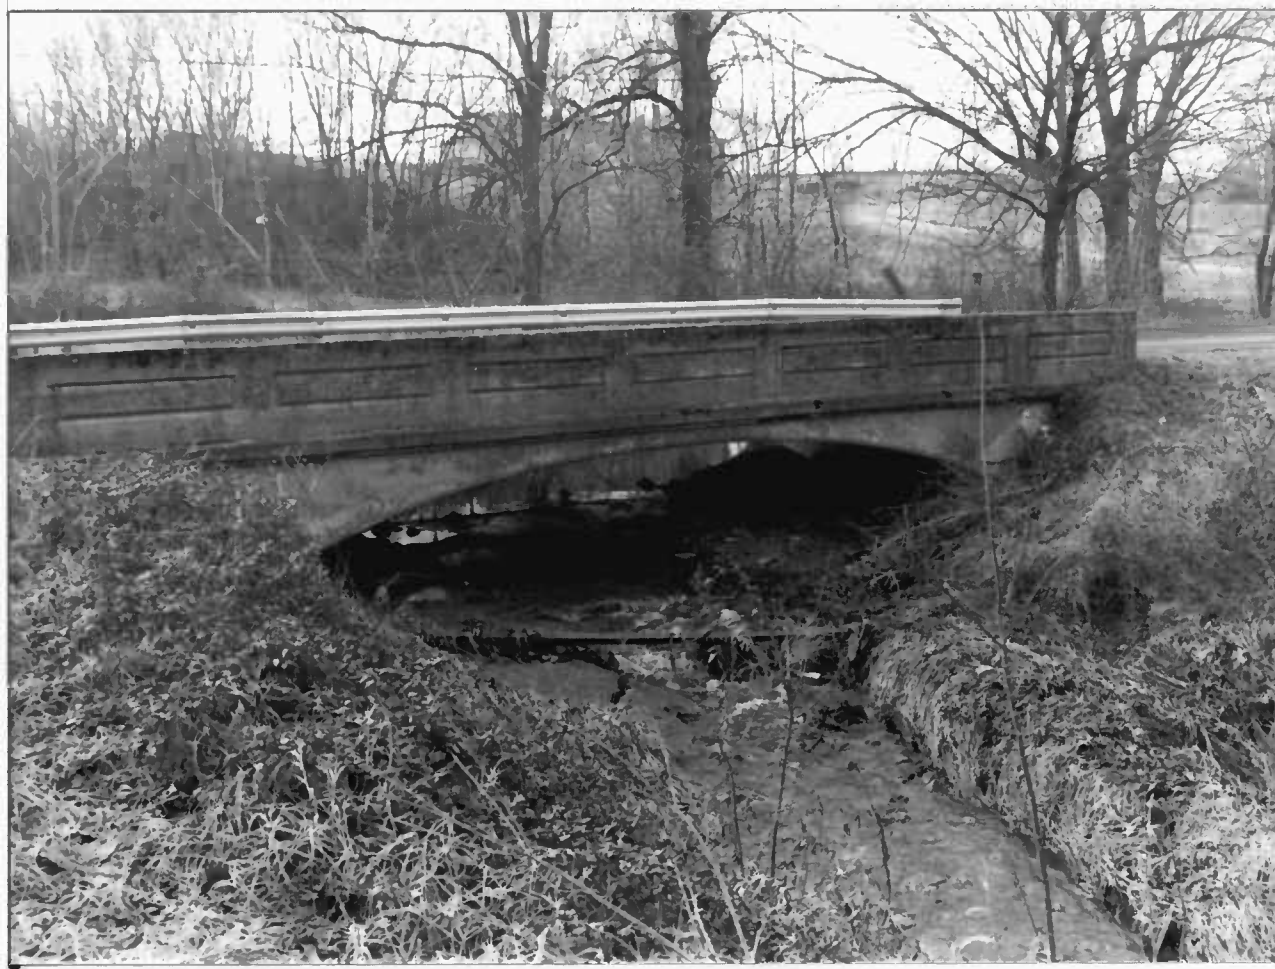
4 OF 4

Bridge W-5981 is a single span filled concrete arch and a concrete slab bridge. The southeastern side of the bridge is an arch. The length of the bridge is approximately 28 feet 4 inches with a clear span of approximately 27 feet 8 inches. There is a clear roadway width of 20 feet. The arch has a 4-foot rise from springline to the crown. The arch has a 1-inch incised molding along the intrados. The spandrel walls are approximately 4 feet high and 3 feet wide. The southeast side of the bridge has its original parapets. The parapet is approximately 28 feet in length. The parapet is a single solid panel with seven incised panels. Each incised panel measures 3 feet by 1 foot with a foot separating each panel. There is an exterior ledge separating the parapet base from the top of the arch. The ledge is 28 feet long, 5 inches high and 4 inches wide. The parapet is in fair condition with minor spalling and cracks. The spandrel walls and the arch ring have minor to moderate spalling and light efflorescence. No large cracks or holes are visible. According to a 1995 inspection report, the bridge is in fair condition with a sufficiency rating of 48.2.

SOUTHEAST ELEVATION
